Zeroes in data

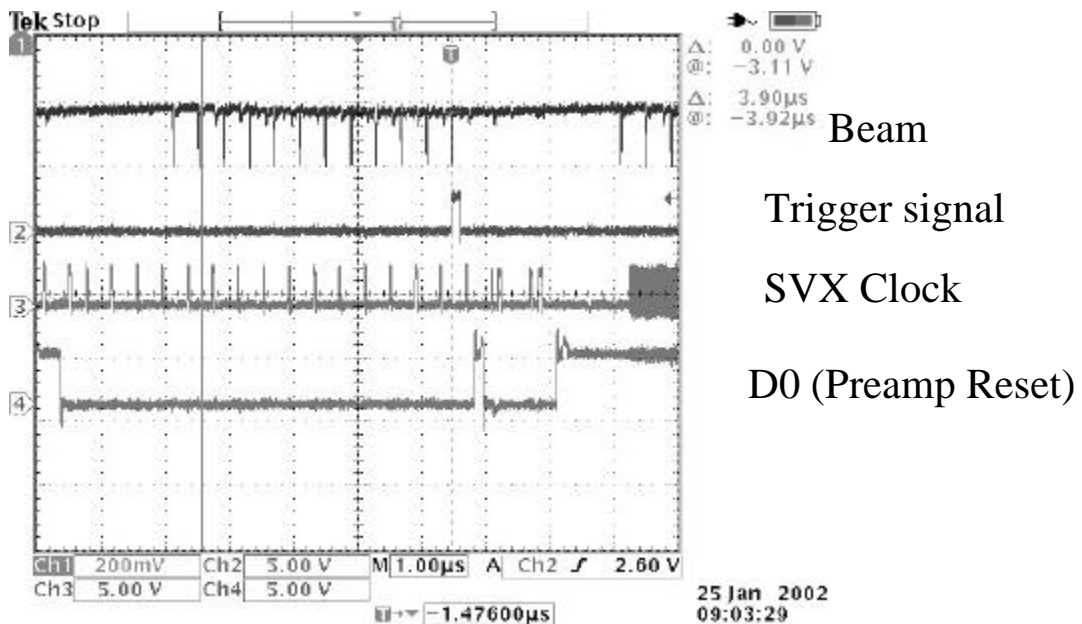
No charge seen in correct pipeline

- Cause: Presence of Preamp Reset (data line D0) occurs near end of Acquire cycle, adversely affecting “ring counter.”:**

- Fix logic to prevent preamp reset during this time**

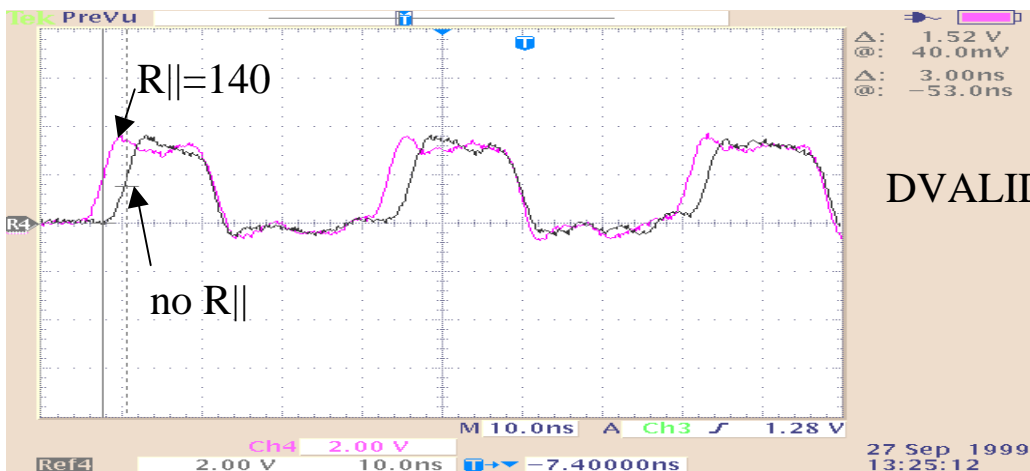
DVALID at IB

1st few DVALID cycles delivered by the SVX narrower than nominal 18.8 ns (at 53 MHz). One of the reasons is bad CLK quality for unterminated CLK line. 1st DVALID width improves from 11ns to 14ns by adding 140Ohm parallel resistor between CLK-CLKB at HDI. Still 1st DVALID narrower than nominal. Associated with SVX driver limitations when trying to drive the 75 Ohm data bus at beginning of readout. Improvement by CLK and/or data bus precharging only marginal.

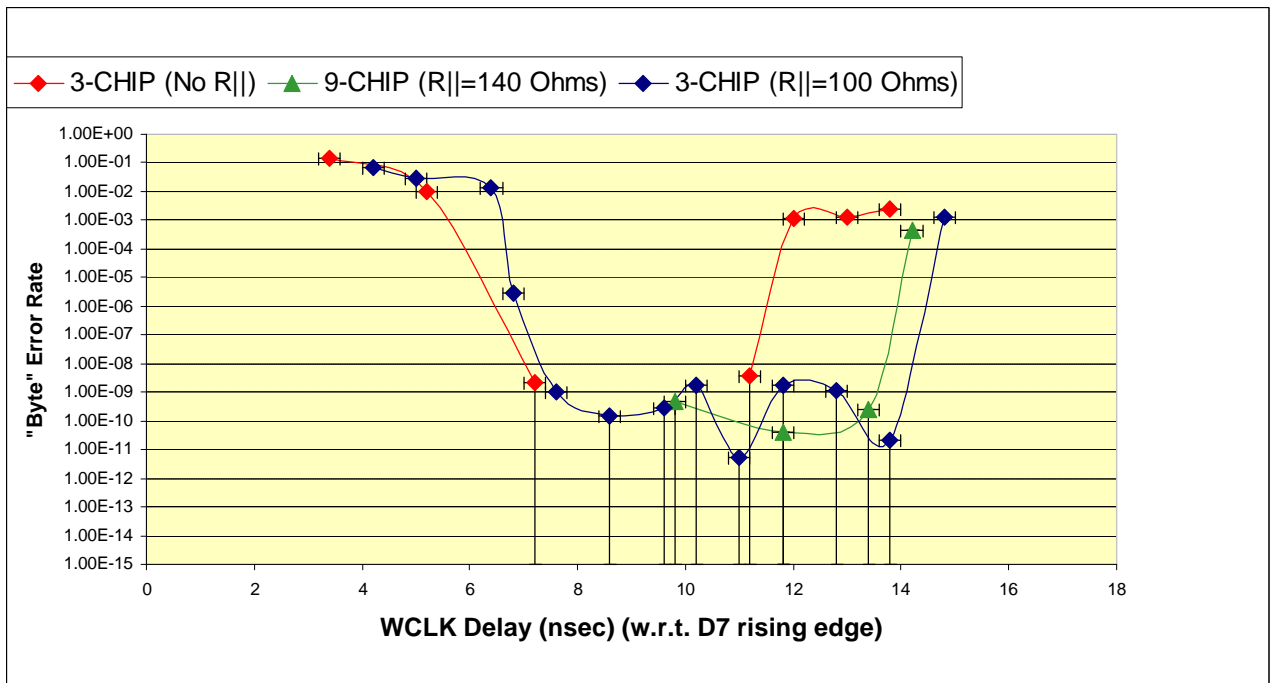
Data Strobing at Sequencer FIFO

Significant improvement in dynamic range for data strobing at the sequencer FIFO by properly terminating CLK lines at the HDI ($R_{||} = 140 \text{ Ohms}$ between CLK-CLKB).

1st DVALID width lower for a 9-chip HDI as compared to a 3-chip HDI presumably due to larger capacitive load.

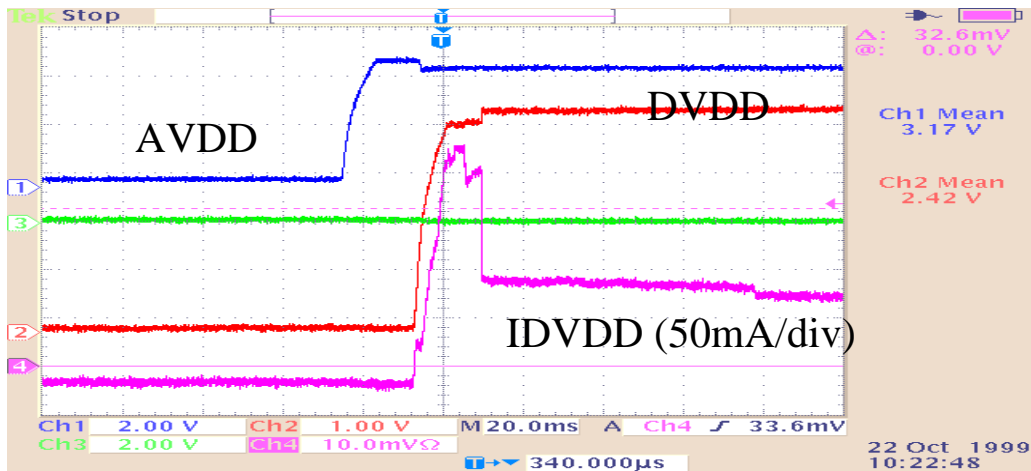
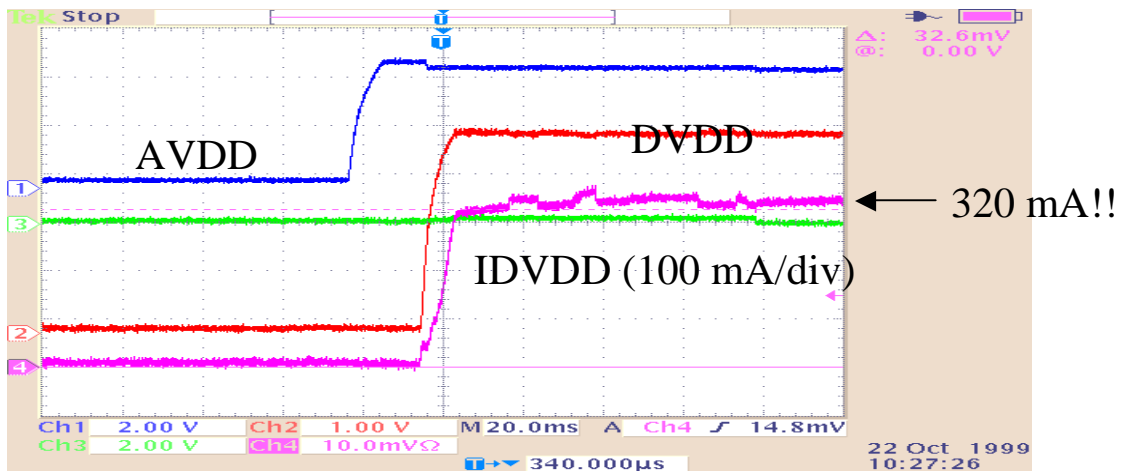
SVX current draw

Large IDVDD draw at turn on. Seems to be a chip feature.
For instance, for a 9-chip HDI onto low-mass cable:

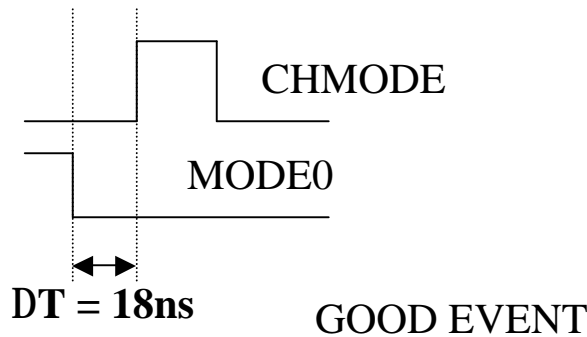
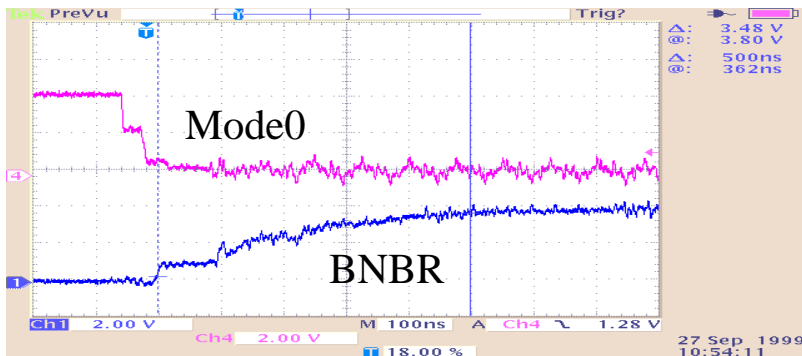
BNBR problem

Aborted readout (BNRB goes LOW) just ~100ns after strobing readout. Typically happening in the first 1-2 events after power-up (high DVDD current mode). Need BNBR comparator threshold at KSU IB low enough so as to not get stuck, because the chip will recover by itself if it is allowed to get next readout. Can also happen if readout not properly strobed. This is cured by moving the CHMODE pulse AFTER the falling edge of MODE0:

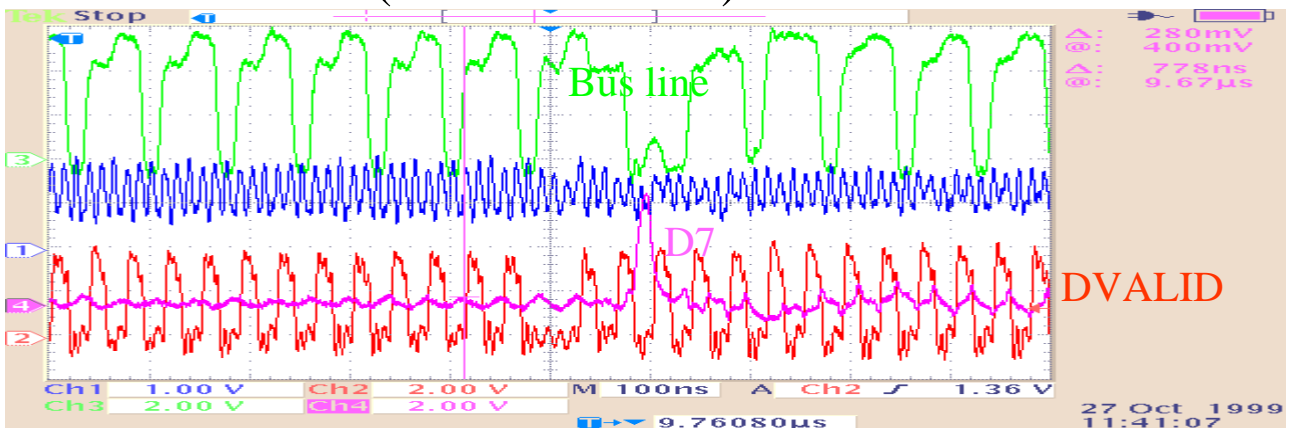
Normal readout (DVDD=4.70 V)

9-chip HDI readout at beginning of 3rd chip

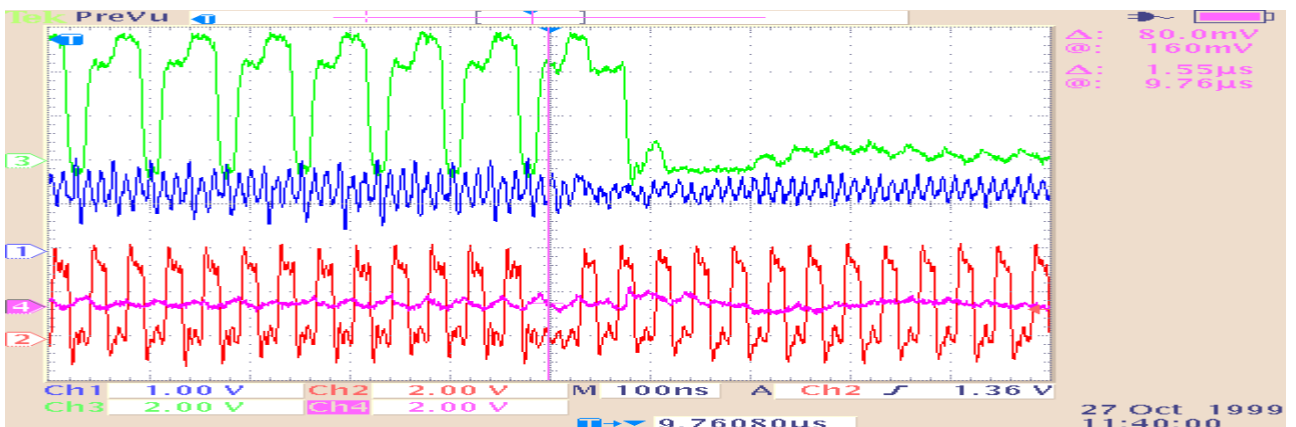
Perpetual readout (DVDD=4.85 V)

Chip will enter in perpetual readout mode due to failure in properly strobing DIGITIZE. Had to lower series resistance for CHMODE and MODE1 at KSU IB sending end in order to get sharper edges. However, the real fix was to extend CHMODE falling edge by +18.8 ns with respect to nominal. The failure was observed when increasing DVDD (changing thresholds at SVX receiver).

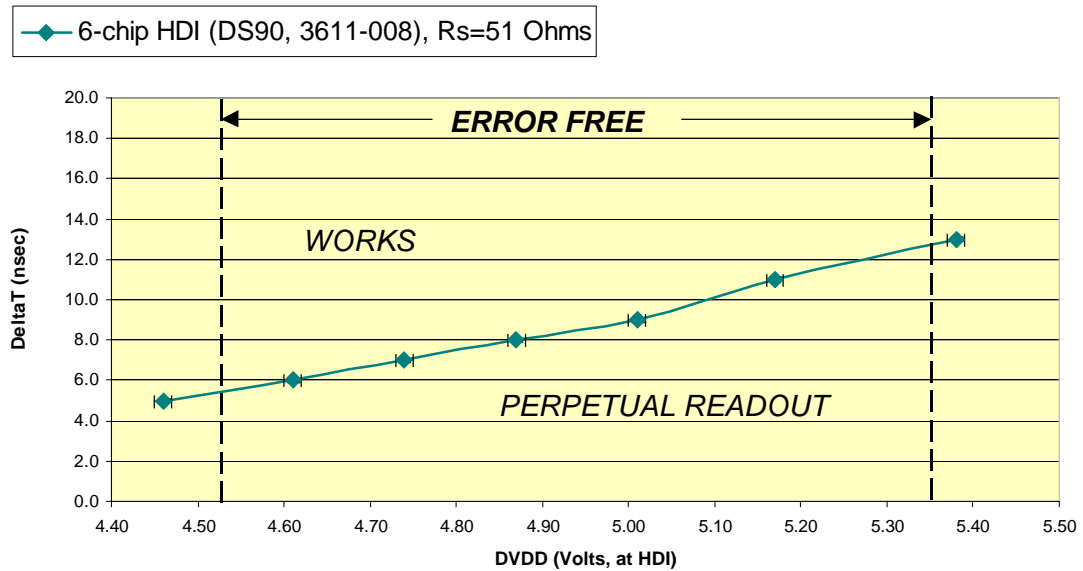
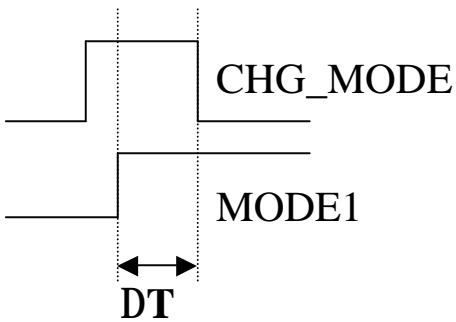
PERPETUAL READOUT problem (cont'd)

To prove that it is a timing problem...

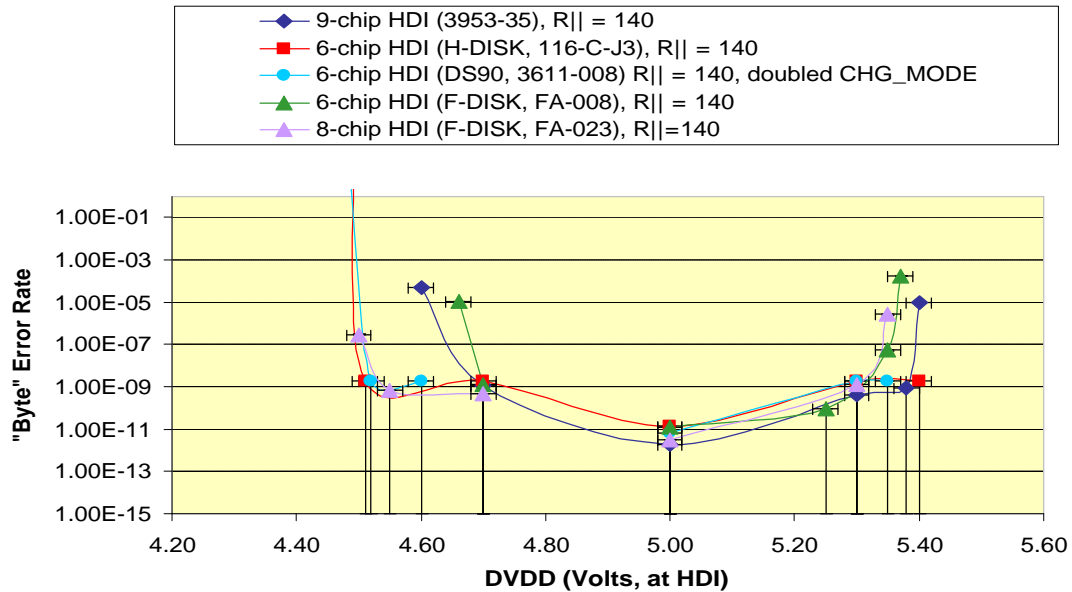
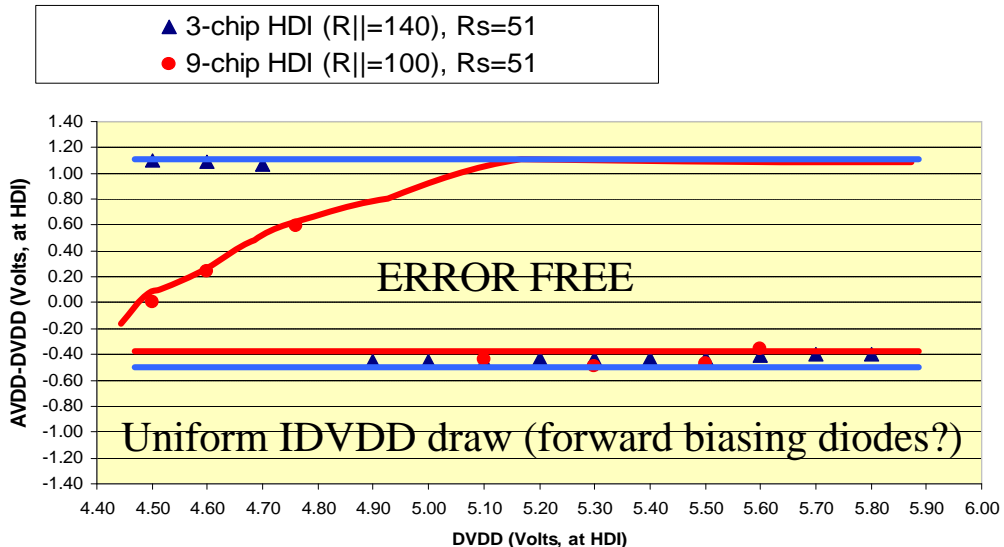
DVDD range

Finite DVDD operating range (after fixing BNBR and PERPETUAL READOUT problems) for the digital part of the chip (we run with fixed data, with normal pedestals the operating range might be different, need to study it).

Rs = 51 Ohms for CNTRL lines at IB, AVDD = 5.0 Volts (at HDI)
